**FIRST FIVE-YEAR REVIEW REPORT FOR
NORTH RIDGE ESTATES SUPERFUND SITE
KLAMATH COUNTY, OREGON**

JUNE 2021

**U.S. Environmental Protection Agency
Region 10
Seattle, Washington**

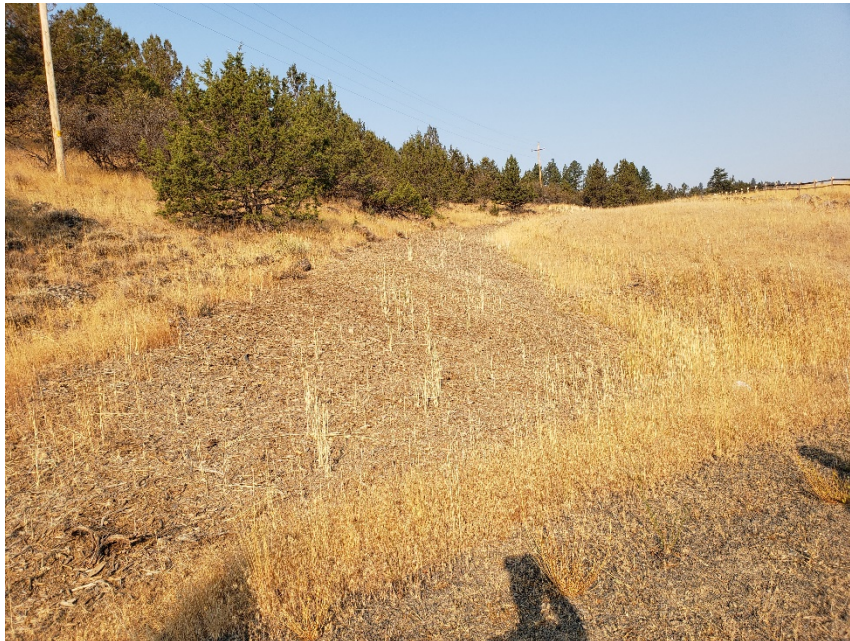
- Swimming Pool Repository (Parcels AG, MBK-E, AL, AI, BL and Y) - Several rills and a rill that transitions to a gully were noted on the slope of the repository.

Swimming Pool Repository mulch area

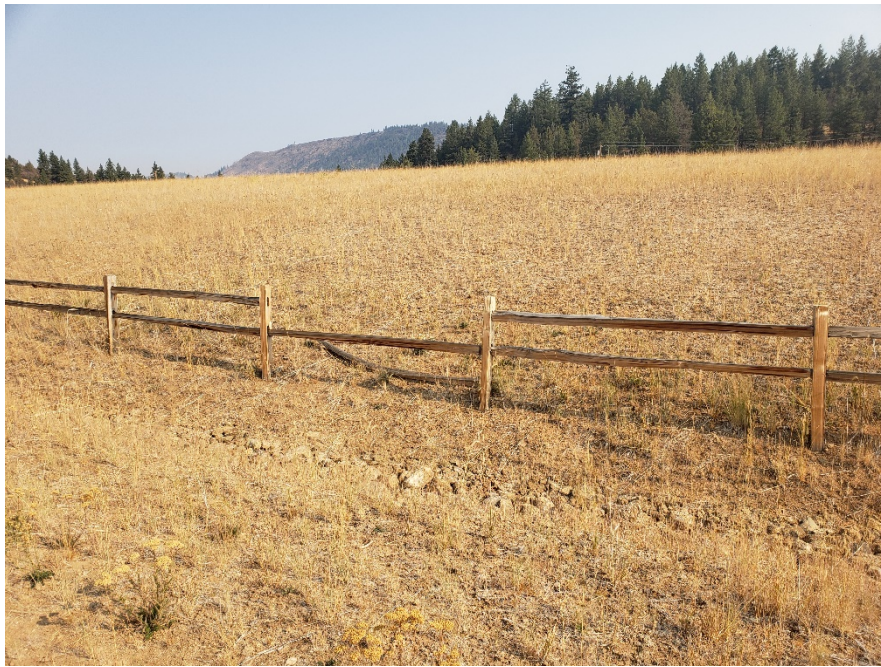
EPA also noted part of Parcel AG, located within the Memorial Park, where vegetation has not become established. Vegetative growth is also impeded above the Memorial Park Repository, where surplus woodchips from remedial construction were distributed. Vegetation is an important element of the remedy and is needed to prevent erosion of the cap.

Memorial Park fence

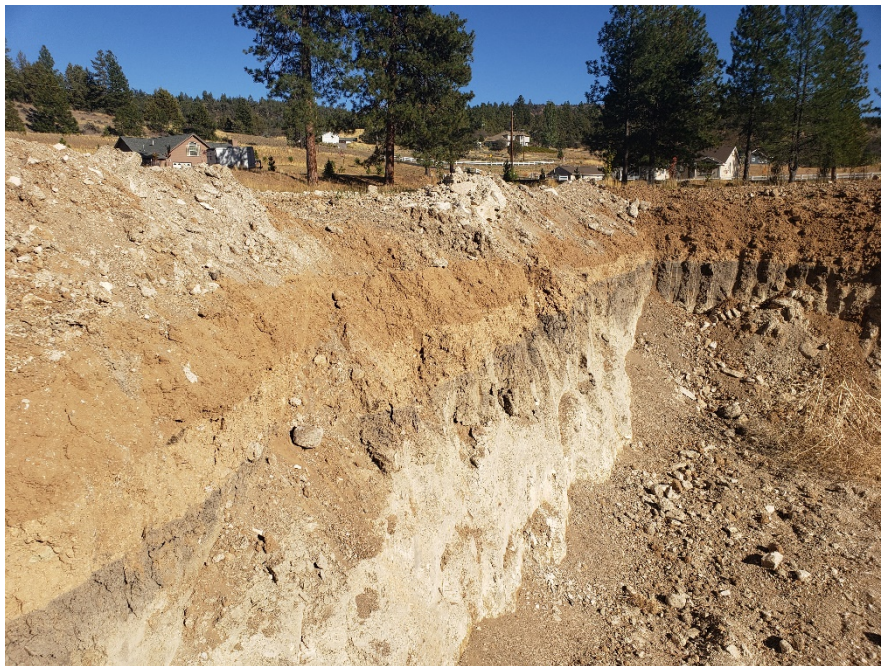
One major finding was the violation of institutional controls on Parcel O, where the property owner excavated greater than 2 feet below ground surface to construct a pond. ODEQ and the property owner determined that the violation resulted from a misunderstanding about the notification process property owners must follow before

digging under the protective cap (greater than 2 feet below ground surface); see Appendix H – Supporting Documentation. The ODEQ, with input from EPA, has now developed a new informational fact sheet for site residents (Appendix K). Further resolution of the Parcel O violation is pending as of the time of this review.

Violation of property institutional controls at Parcel O

- On-site excavation on Parcel O by the current resident suggests potential issues with the institutional controls and excavation approval requirements. However, this violation was promptly reported to the state and the property owner partially followed the excavation and notification requirements; this indicates that this violation likely resulted from the resident misinterpreting the requirements rather than intentional violation. To address this in the future, the state has developed an information fact sheet to distribute among residents to better clarify institutional control requirements. EPA has reviewed and provided approval of the draft fact sheet as of October 2020. The final fact sheet is attached as Appendix K.
